KEMESS SOUTH MINE RECLAMATION AND CLOSURE

ABSTRACT

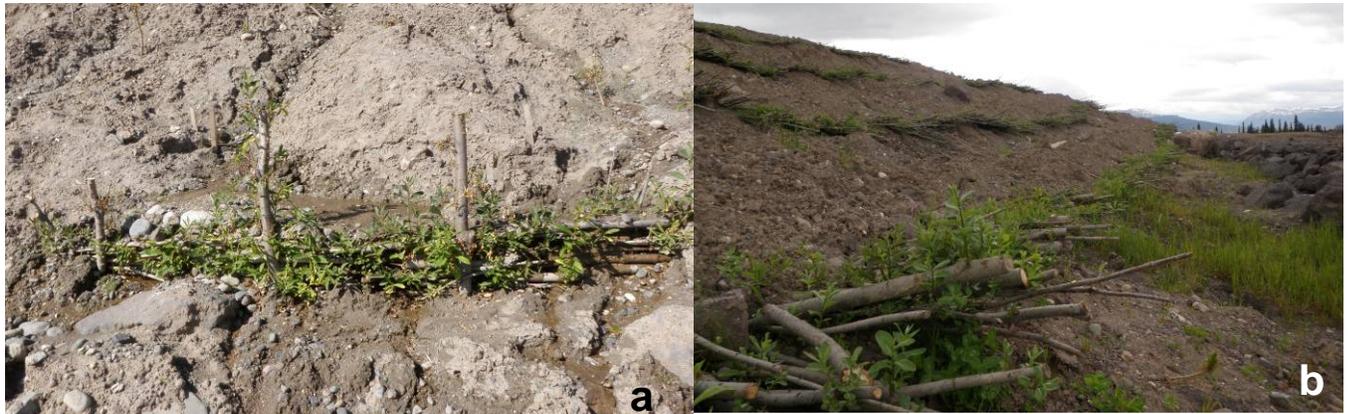
Photo 1. Willow wattle fences on Borrow 7 seepage areas (a), and willow brush layers for improvement of surficial soil stability (b).

Willow staking has been conducted on site in various areas since 2000. Due to the large willow collection programs conducted in 2009, application of a greater number of bioengineering techniques (Polster, 2005) was possible in summer 2009 and 2010. Willow wattle fences (Photo 1a) were applied on hillsides with known seepages, in combination with live pole drains and willow staking. Brush layers (Photo 1b) were applied to slopes with surficial instability, and live pole drains were installed in talus areas to reduce rilling and to direct surface water to diversion structures.

An old soils dump in the western portion of the borrow had previously failed, moving as an earth flow. This area was initially recontoured in 2006, which improved stability. However, surficial sloughing and slumping still occurred in 2007 and additional work was required in 2009 to improve stability. A NAG rock toe berm was constructed along the base of the slopes, additional recontouring was then conducted to further reduce the slope angle, followed by installation of willow brush layers to provide additional stability and control seepage water.

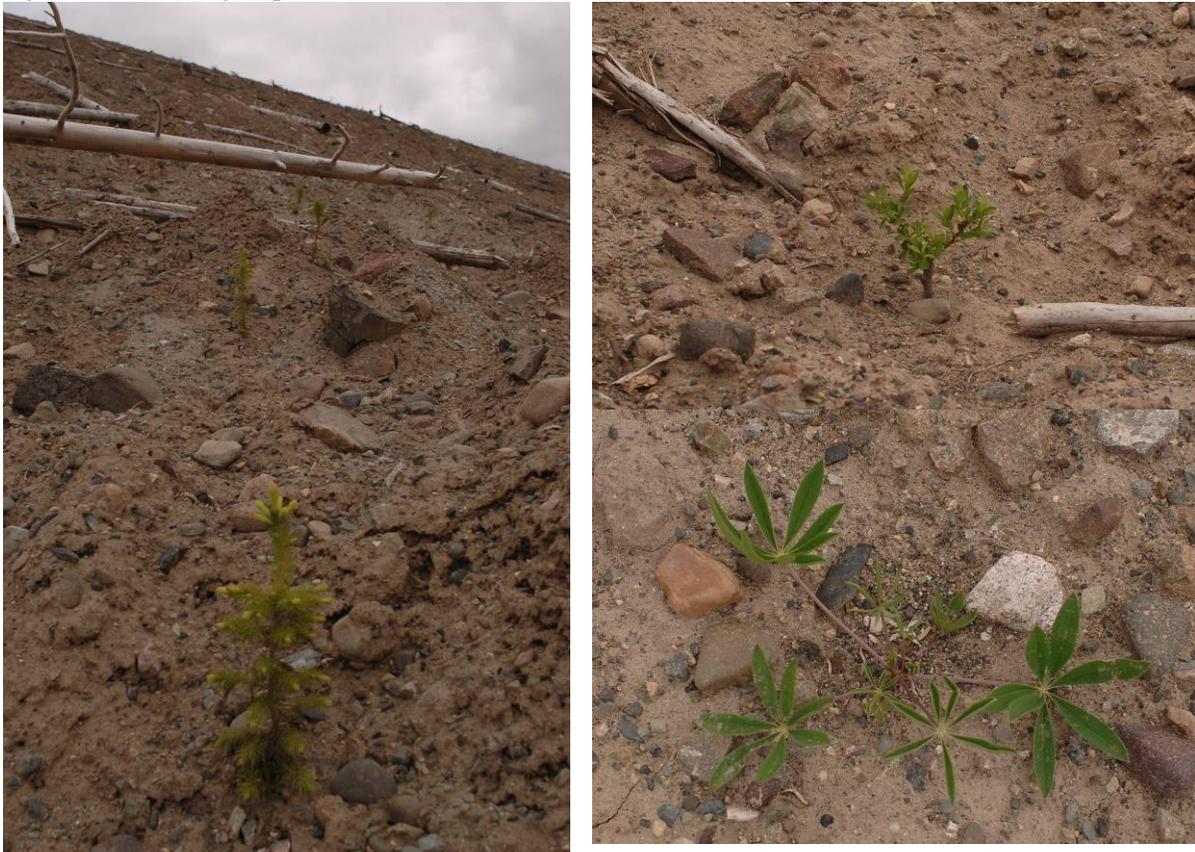
Photo 2. Dam face rough and loose preparation, coarse woody debris, and vegetation (white spruce, arctic lupine and willow)

The closure work on the downstream side of the dam commenced in summer 2008 with resloping and contouring of the sand buttresses, such that they drain back and away from the crests. Overburden was then placed on top of the contoured sand to a thickness of 0.3 m on slopes and 0.2 m on buttress surfaces. The surface was then roughened using an excavator and/or ripped using a dozer as appropriate to obtain a “rough and loose” final surface. This rough surface extends to the sand layer in some locations, which also improves drainage of surface water into the underlying sand layer. Coarse woody debris was spread over the slopes to provide wildlife habitat and to further encourage establishment of micro-sites for ingress of native vegetation. The rough and loose surface preparation has proven to be effective in controlling surface snow melt, as witnessed in both the 2009 and 2010 spring melt seasons. Little to no erosion was observed on dam slopes (Photo 2).

Observations made in early August 2009 indicated that the seedlings and plugs were doing well and that native vegetation had started to appear on the prepared dam surface, and this has been confirmed by observations made in June 2010 (Photo 2). This suggests that the rough and loose surface preparation technique does create favourable conditions for capturing the seeds of wind-borne species. Some supplementary planting of native species is planned for future years, however it is expected that the density of native species will increase with gradual ingress over time. Additional observations will be conducted in the summer of 2010 to assess the success rates of planted native species and to monitor ingress and infilling of plant cover over the reclaimed surface.

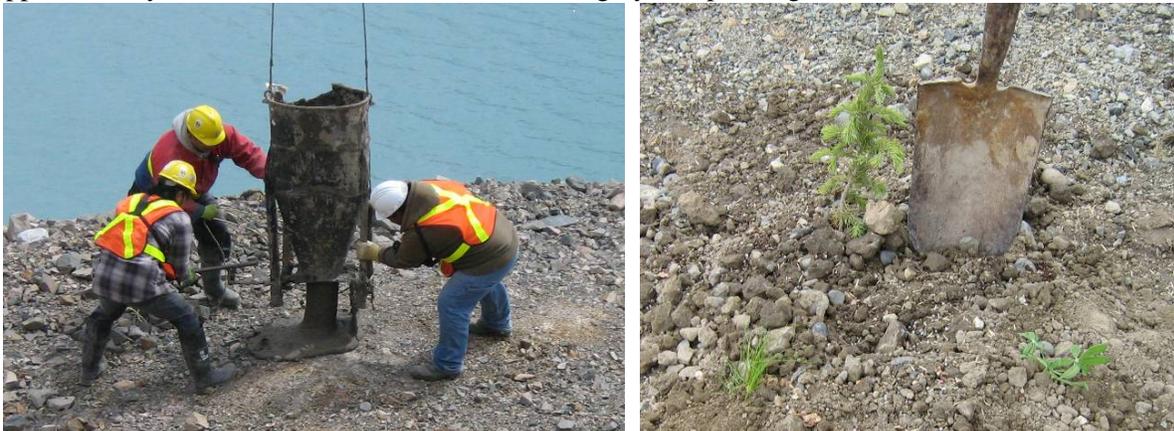
Photo 3. Soil delivery to Borrow 3 via helicopter and soil pocket planting with native species

Borrow 3 is located on the north side of the Tailings Storage Facility (TSF). This borrow was one of the rock and overburden sources used during early construction of the TSF. Later borrow development consisted of mining talus for filter materials. Machine reclamation work was carried out in this area in 2005, including recontouring of old borrow benches and development trails. The steep rocky slope section of Borrow 3 was addressed during the 2009 reclamation activities. The objective of the 2009 program was to create micro-sites or “pockets” for establishment of vegetation on the exposed rock slope. Some pockets of vegetation have already established naturally in this area, and the intent was to augment these with additional sites. A lack of a suitable growth medium at the borrow area meant soil had to be moved to the site. Overburden from the mine site was mixed with water to form a slurry in preparation for relocation. Due to difficult access, a helicopter was used to sling the slurry to the borrow. Approximately 7 m³ of soil was moved to create roughly 150 planting sites (Photo 3).

Around 100 subalpine fir seedlings were transplanted to Borrow 3 from Borrow 10. Arctic lupine and alтай fescue plugs (150 of each) were planted in the prepared soil pockets (Photo 3). A mid-high elevation seed mixture and mountain sorrel seeds were spread on the islands along with slow release fertilizer. Success of the planting and seeding was assessed in June 2010. The extremely dry weather experienced in summer 2009 resulted in high tree mortality, however the grass plugs and seed mix are growing successfully. These sites will be reworked in 2010 by breaking up the soil, adding additional growing medium and seeding.

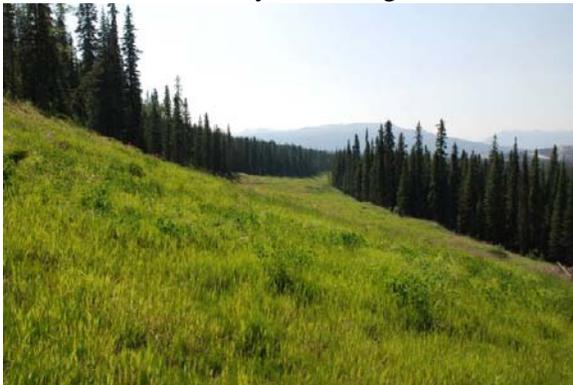
Photo 4. Reclaimed construction right of way

into contained areas, among other things. Construction roads and accesses no longer needed for operations were also reclaimed as the areas were available. These areas include road access to Mill Creek, and a secondary alignment cut parallel to the tailings access road (Photo 4). Recontouring, seeding and planting, and coarse woody debris placement was completed and these areas are considered reclaimed.
